Three Canyons/Palominas Parcel, AZ Conservation Easement Documentation Report

Prepared by: Kimberlee K. Mulhern

Date: October 22nd, 2013

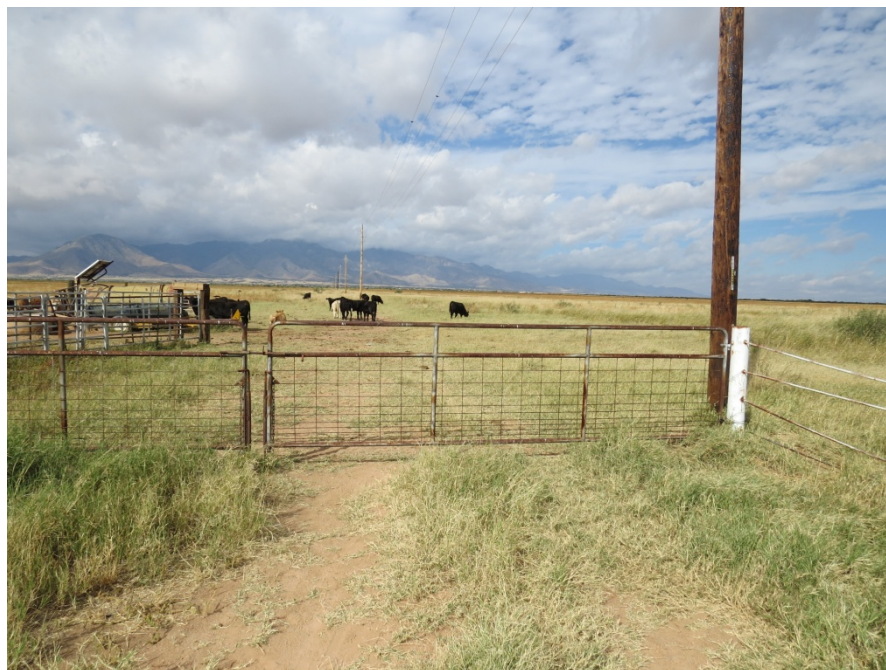
Photograph #1. The entrance gate onto the property is located on the east side of the Section looking west, approximately one-half mile to the south of the junction of Three Canyons Road and Palominas Road. SSVEC power transmission line transits the property on east-west line.

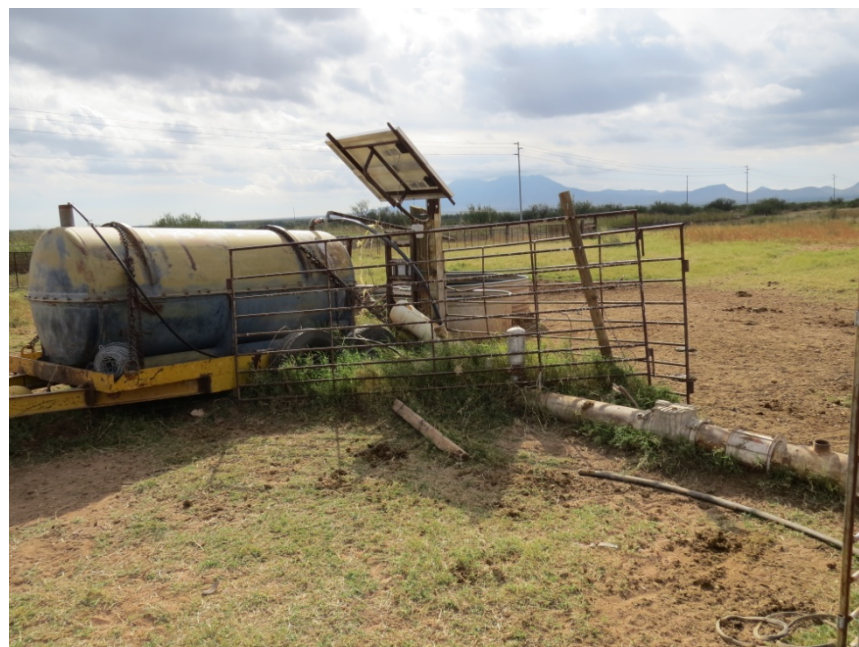
Photograph #2. The first wellhead is located closely adjacent to the entrance gate. There is a submersible pump in the well head that pumps water to the water wagon for distribution to three livestock tanks. View is looking to the southeast from the northwest side of the wellhead.

Existing Condition: Only the east well is currently in operation. The north well has an unsecured cover, and the south well is open.

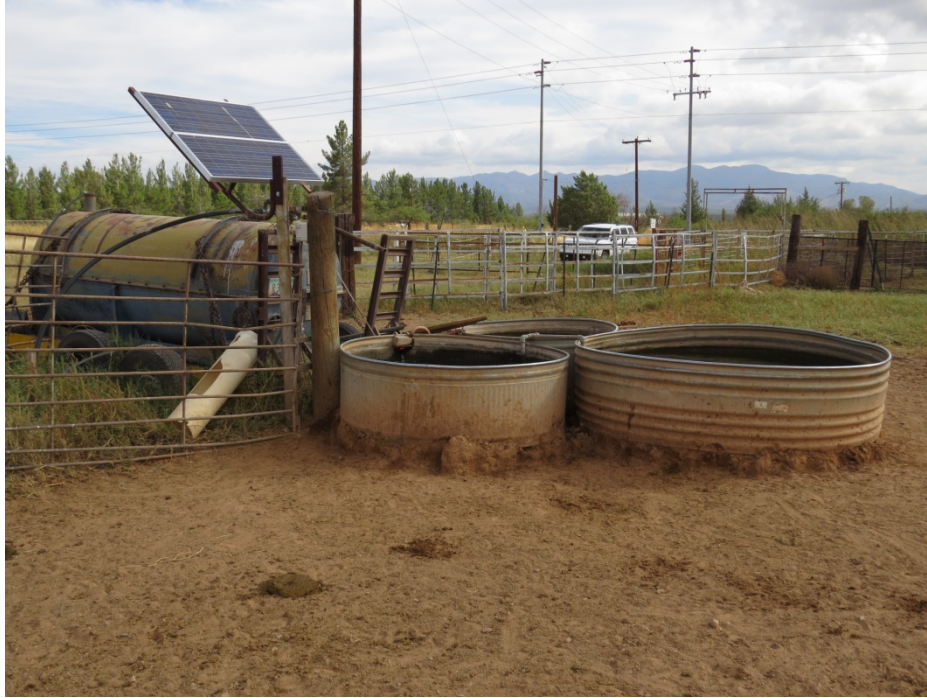
Photograph #3. Three livestock tanks are adjacent to the south of the first wellhead. Solar panel provides power for water pump. View is to the east northeast.

Existing Condition: The only features which can generate an electromagnetic field currently on the parcel are the SSVEC transmission line and the solar panel at the east well.

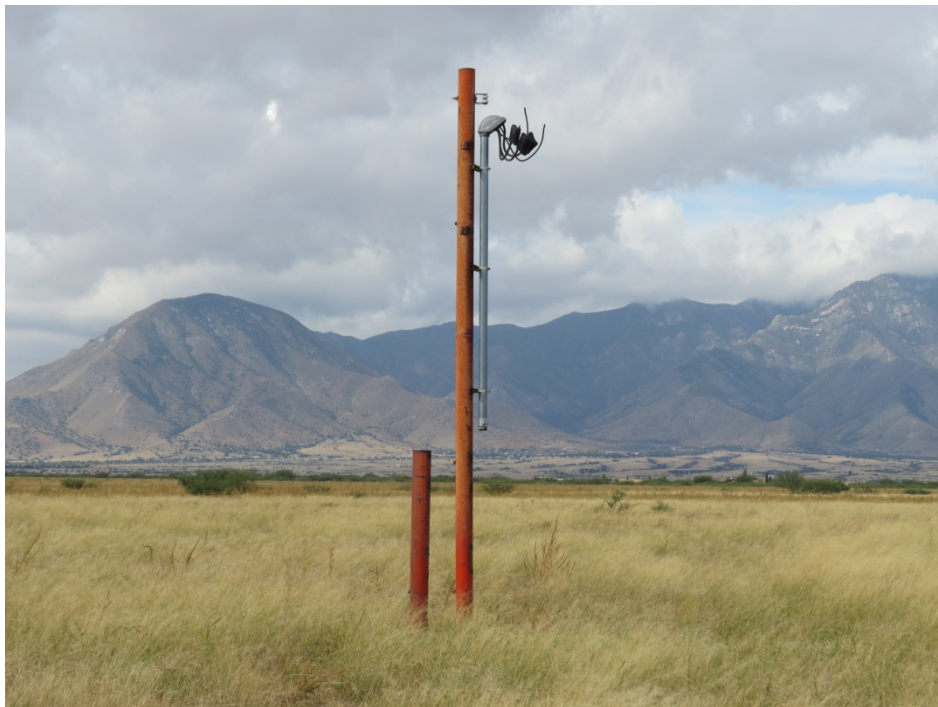
Photograph #4. Old metal power pole and a metal post (both painted orange) are located to the south of the SSVEC transmission line. View is to the west. This appears to have taken power from the SSVEC transmission line for use in pumping groundwater.

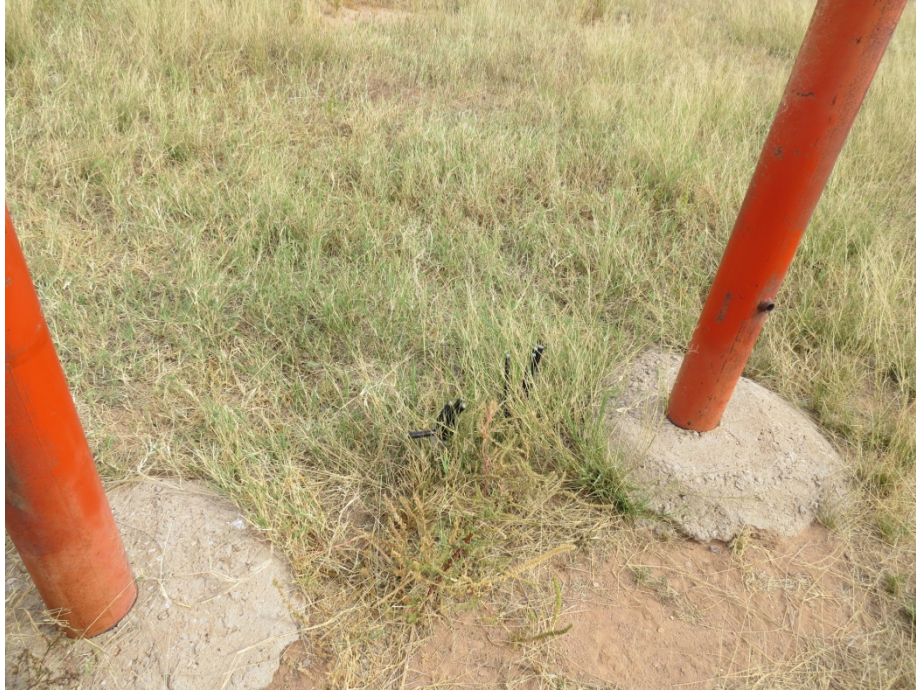
Photograph #5. Power lines to the wellheads and then to the center pivots were located in the ground between the two orange poles shown in Photograph #4 above.

Existing Condition: There are old tires and rims as well as wooden cable spool parts present in the southwest quarter of the northwest quarter of the section. There are remnants of the old water piping system from the wellheads to the center pivots, some of which have been removed and are visible on the surface. There are subsurface electrical cables from the transmission line to the wellheads.

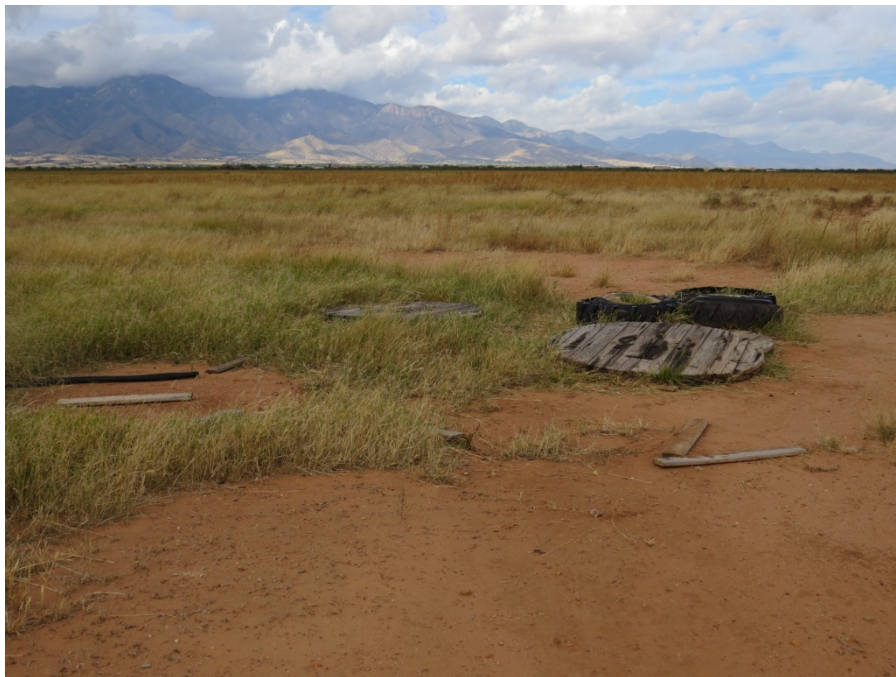
Photograph #6. Old implement tires and rims and a cable spindle are located outside the pivot area in the grass of the southeast quarter of the northwest quarter of the section.

There is very little debris on the Property with the exception of some old tires and rims and wood from cable spools. Although the aerial photograph shown in Exhibit 4 indicates the approximate location of the former runway in the northwestern quarter of the Property, there is little on the ground to distinguish the area from its surroundings.

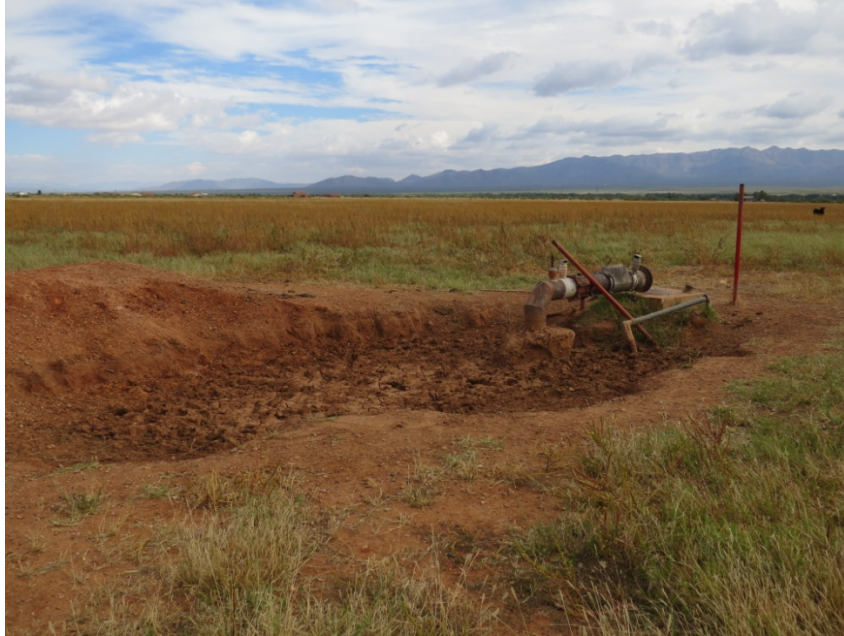
Photograph #7. Photograph of agricultural well distribution system for agricultural well in northeast quarter section, looking east northeast. System remains in place. Precipitation accumulates in the pit that livestock use when grazing. Electrical power was in pipe laying down to the south of the distribution system.

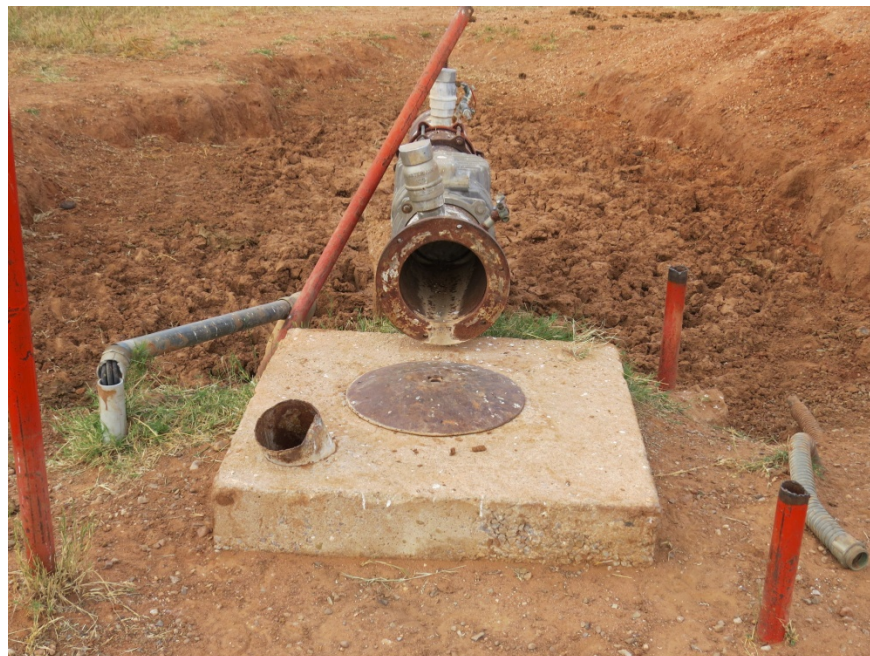
Photograph #8. Wellhead and vent pipe in concrete pad surrounding wellhead for the agricultural well in the northeast quarter section, looking west. A metal plate has been placed over the wellhead. Vent pipe is uncovered but is filled with soil

The northern well has a metal plate covering the wellhead which needs to be secured following acquisition of the Property. Vents at the wellhead also need to be secured. The southern well has no cover over the wellhead. The wellhead and vent need to be secured following acquisition of the Property.

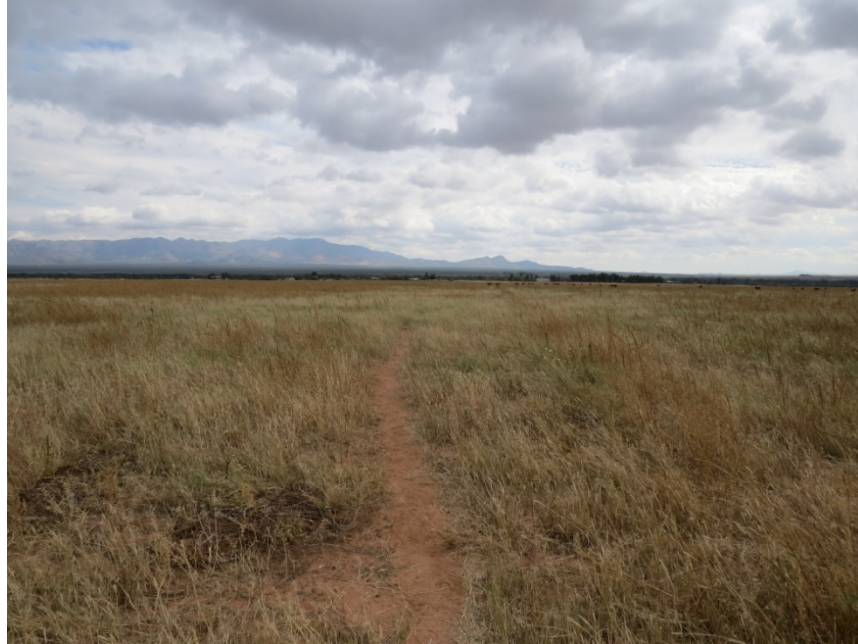
Photograph #9. This grasslands photograph was taken from location halfway between pivot systems for northeast and northwest quarters of the section looking east to the Mule Mountains..

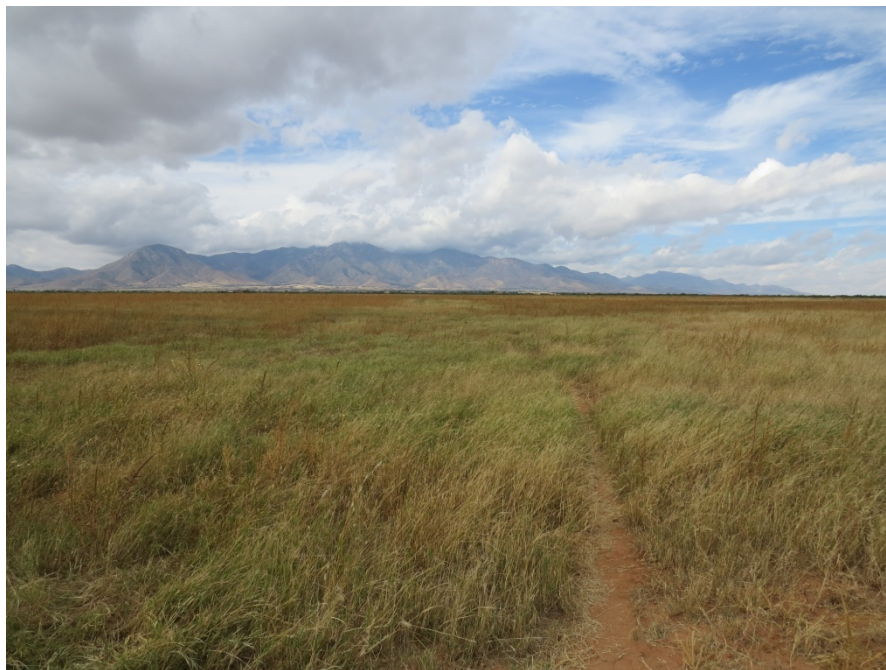
Photograph #10. This grasslands photograph was taken from location halfway between pivot systems for northeast and northwest quarters of the section looking west to the Huachuca Mountains..

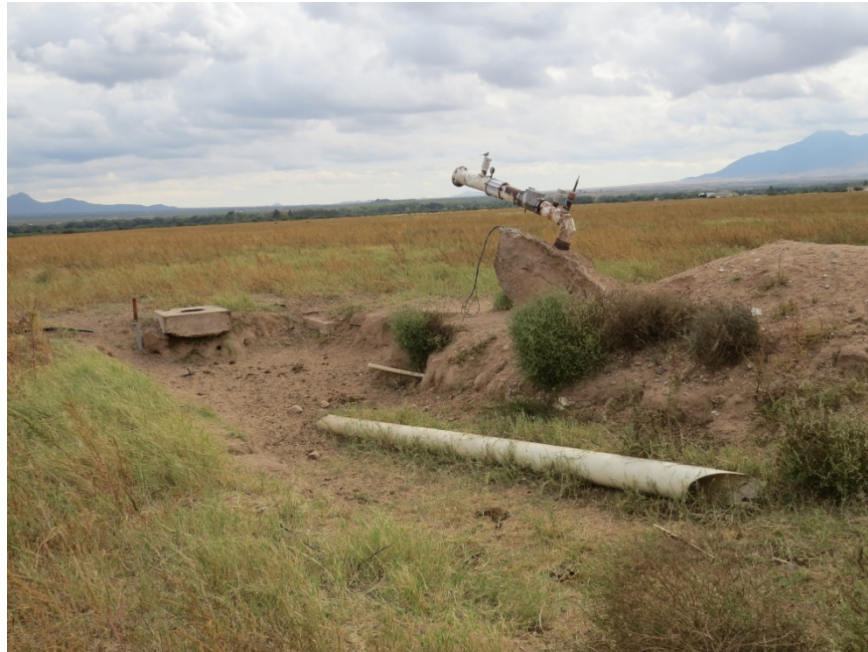
Photograph #11. The photograph of the excavated distribution system for the agricultural well in the southeast quarter section is taken looking to the southeast. Eight inch PVC piping was used to convey water to center pivots.

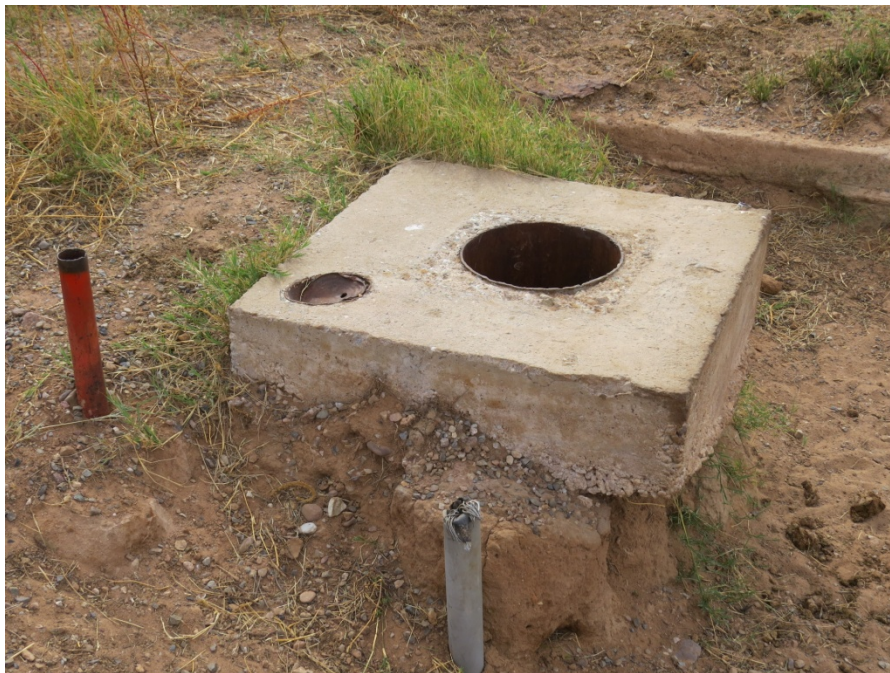
Photograph #12. This photograph of the wellhead for the agricultural well in the southeast quarter of the section, looking to the south southeast. Wellhead is open, with vent pipe covered but in poor condition. Electrical cable pipe is in the foreground.

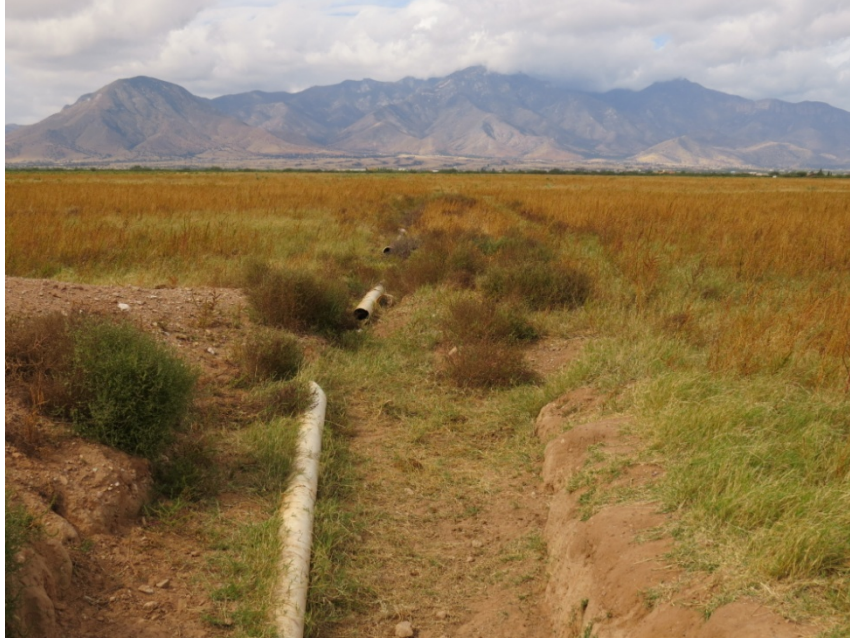
Photograph #13. This photograph is taken from the wellhead for the agricultural well in the southeast quarter of the section, looking west to the Huachuca Mountains. There is an open ditch in the area with remnants of the eight inch PVC pipe in the bottom.

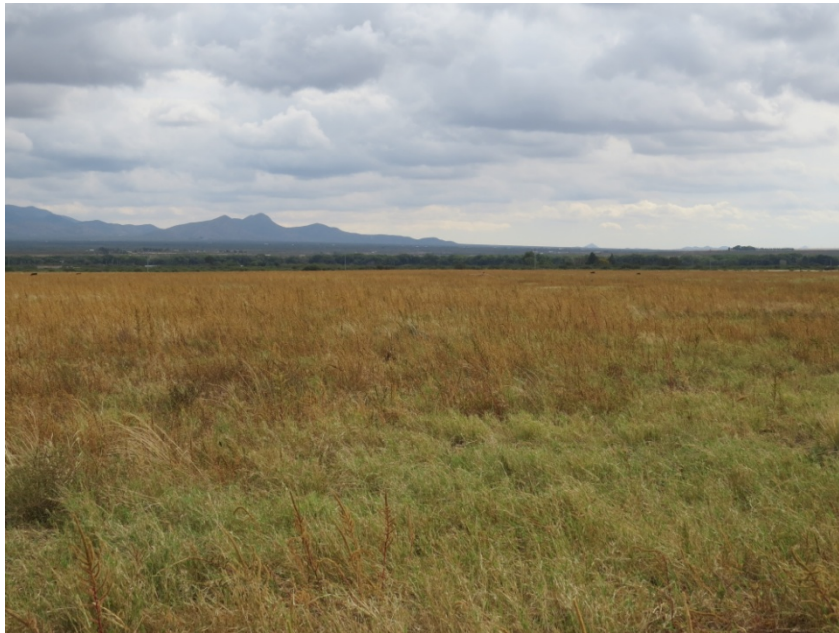
Photograph #14. This photograph is taken from the wellhead for the agricultural well in the southeast quarter of the section, looking east to the Mule Mountains.
